# **Spread Eagle Chain of Lakes** (Florence County, Wisconsin)

# Eurasian water-milfoil Control and Monitoring Report

**Cite as:** Stine, Angie and Dean Premo. 2020. Spread Eagle Chain of Lakes Eurasian water-milfoil Education and Monitoring Report. White Water Associates, Inc.

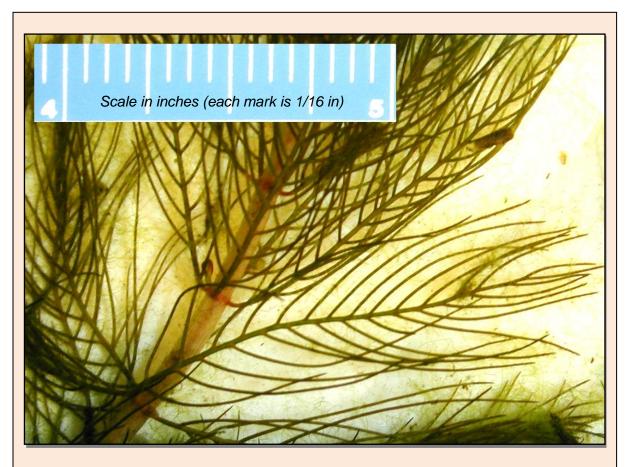
Exhibit 1. Photograph of Eurasian water-milfoil (Myriophyllum spicatum).

Eurasian water-milfoil (EWM) can be aggressive AIS. Eurasian water-milfoil is identified by having whorls of finely divided leaves. EWM usually has 14 or more leaflets on each side of the leaf axis (see Exhibit 1). Native water-milfoils usually have fewer than 12 pairs of leaflets. EWM is detrimental to lakes because it can form dense mats, preventing light from reaching other native plants and can interfere with boating and other recreational activities. EWM reproduces by buds, rhizomes and by mechanical fragmentation (such as being chopped up by boat engine propellers). The high level of boating traffic in the Spread Eagle Chain of Lakes increases the chances for this species to disperse throughout the chain.

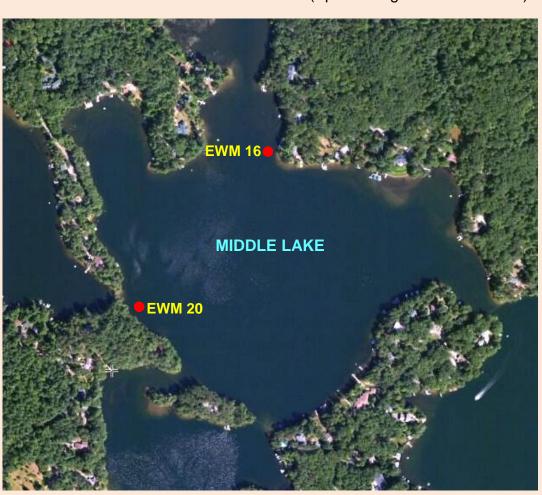
Exhibit 5. EWM Locations on Middle Lake (Spread Eagle Chain of Lakes)

On September 5, 2019, Angie Stine and Jay Weber meander searched. EWM 13 had five plants. EWM 19 had two EWM plants. EWM 12 had two plants. Middle Lake had a new find at EWM 20 (Exhibit 5) with only two EWM plants. EWM 16 had two EWM plants.
